# Manhole Inspection Summary

Manhole # S35Q\_\_032MH

Insp Date: **3/21/08 10:20 AM**

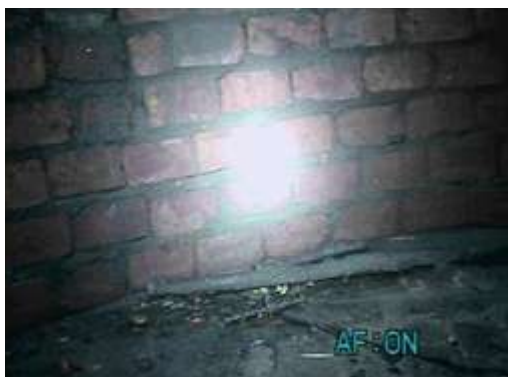
Miscellaneous

bench debris

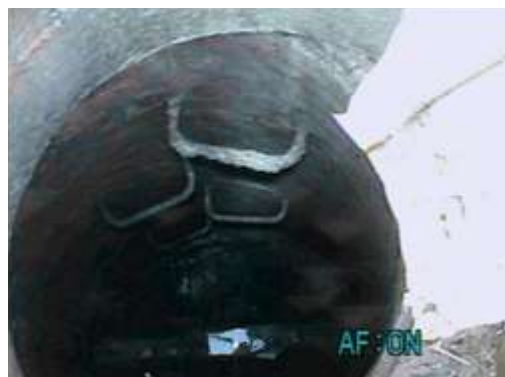
Defect 2

**Steps** Count: **4** Missing: **0** ☒ Corroded

steps

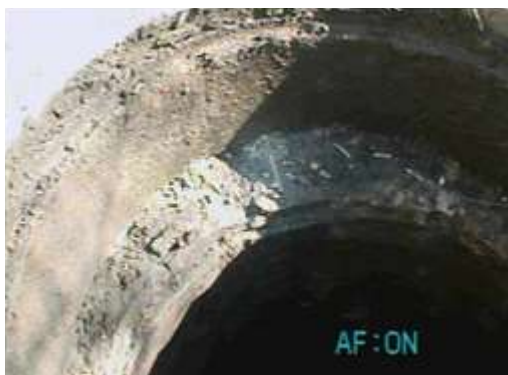
Defect 1

**Frame** Offset: **4** (in.) Condition: ☒ Sound ☐ Cracked ☐ Leaks

offset
